**CERCLA
EXPANDED SITE INSPECTION ADDENDUM REPORT**

Eagle Zinc Company

Hillsboro, Montgomery county, Illinois

September 1, 2005

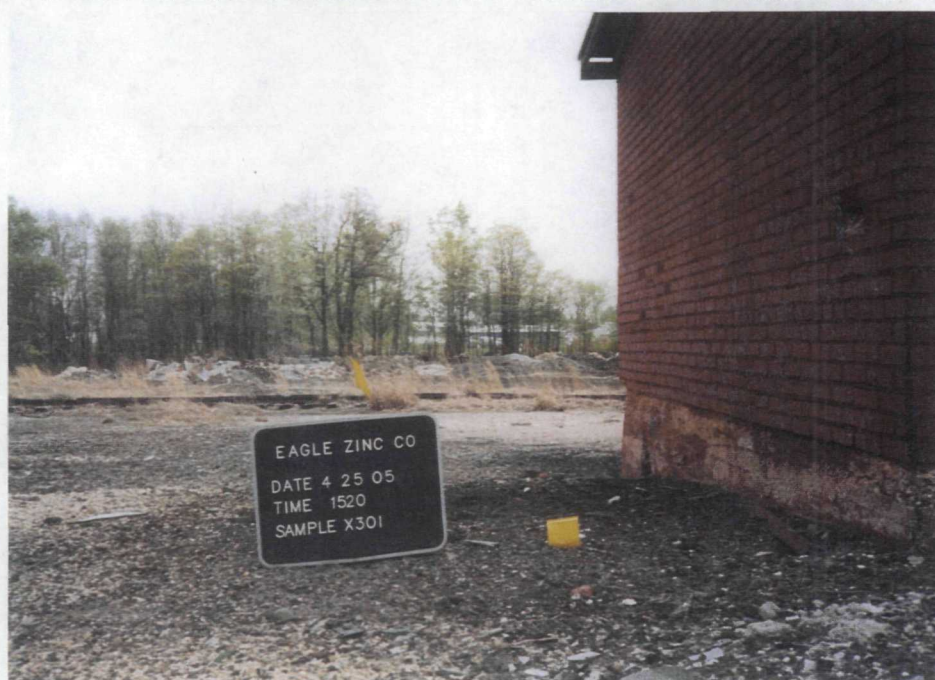
Sample X301 was
collected at the
southeast area of
the site from a
black cinder pile.

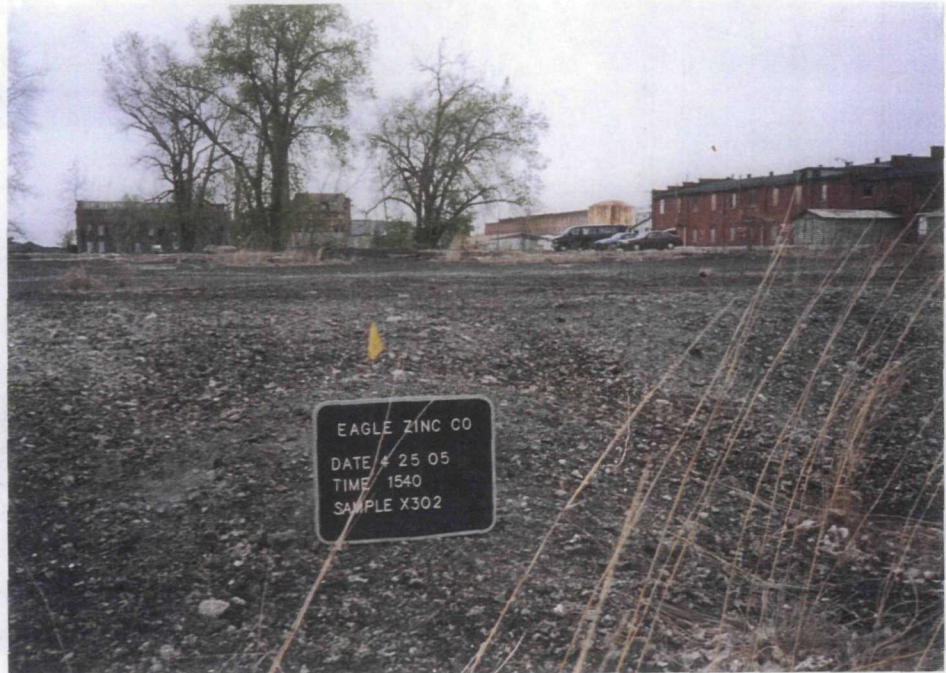
DATE: 4/25/05	SITE ILD#: 980606941	COUNTY: Montgomery
TIME: 15:40	SITE NAME: Eagle Zinc Co.	
PHOTOGRAPH TAKEN BY: R. Casper		
COMMENTS: Picture taken toward: North.		
Photo Number 3.		
Sample X302 was collected at the south area of the site from fine black cinders.

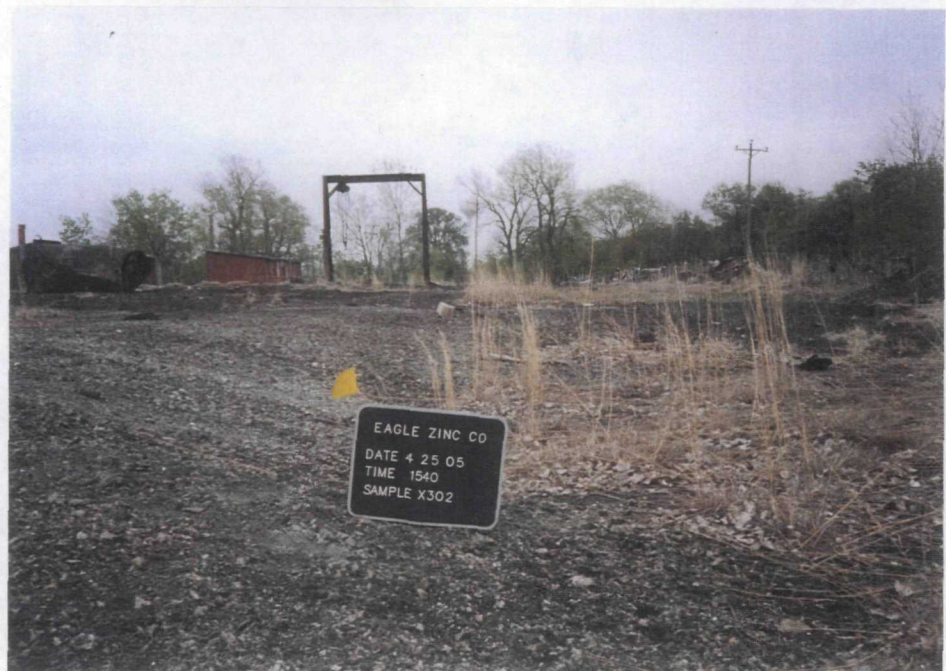
DATE: 4/25/05
TIME: 15:40
PHOTOGRAPH TAKEN BY: R. CASPER
COMMENTS: Picture taken toward: East.
Photo Number 4.
Sample X302. The area contains little vegetation. Collected at a depth of 0 to 2 inches.

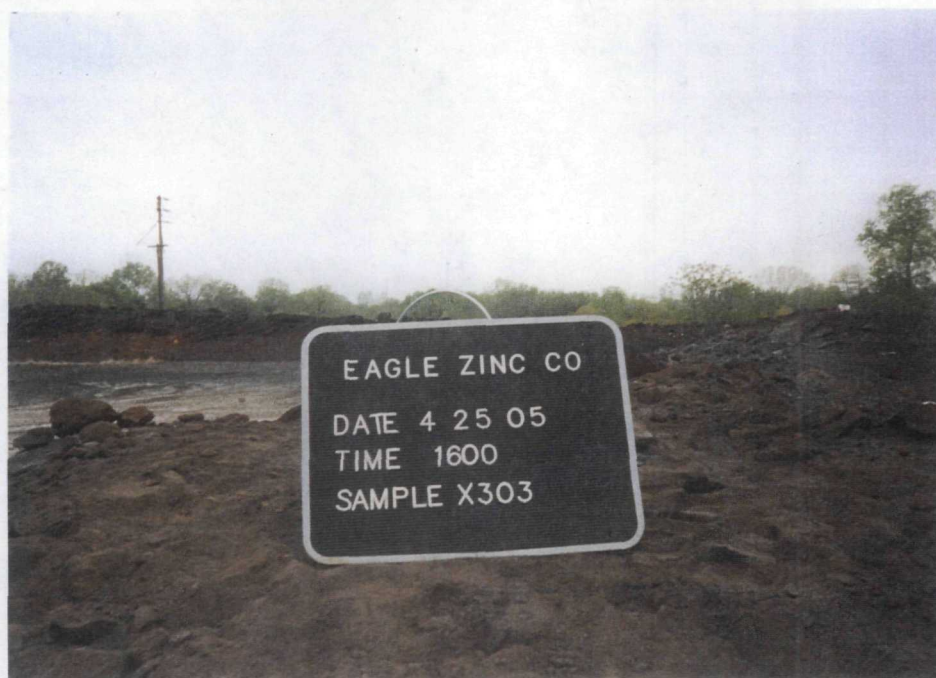
PHOTOGRAPH TAKEN BY: R. Casper
COMMENTS: Picture taken toward: West.
Photo Number 5.
Sample X303 was collected at the southwest area of the site from a slag material.

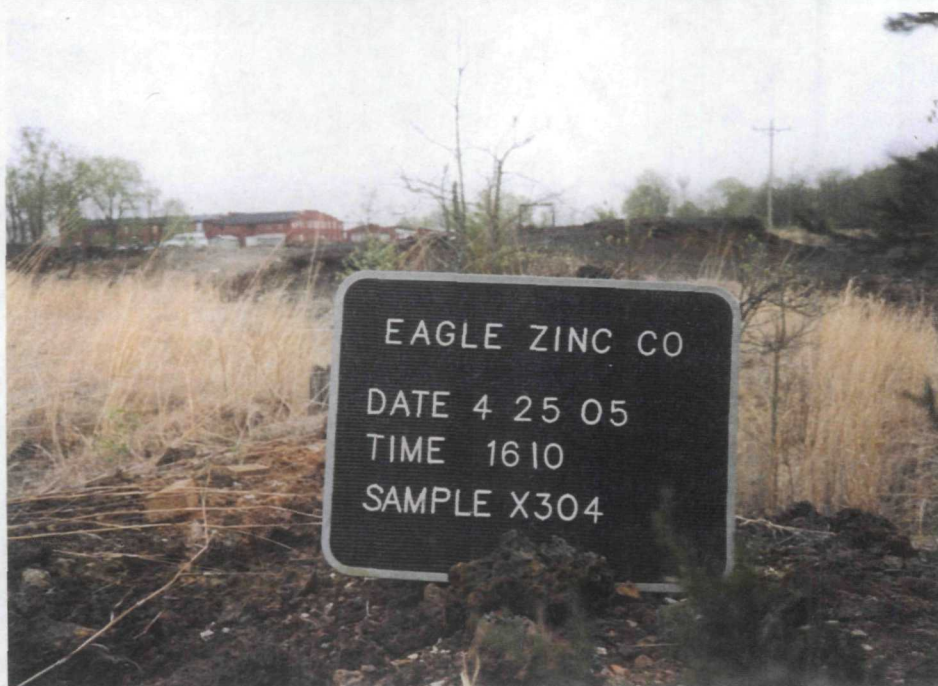
DATE: 4/25/05	SITE ILID#: 980606941	COUNTY: Montgomery
TIME: 16:10	SITE NAME: Eagle Zinc Co.	
PHOTOGRAPH TAKEN BY: R. Casper		
COMMENTS: Picture taken toward: East.		
Photo Number 7.		
Sample X304 was collected at the southwest area of the site from a slag pile.

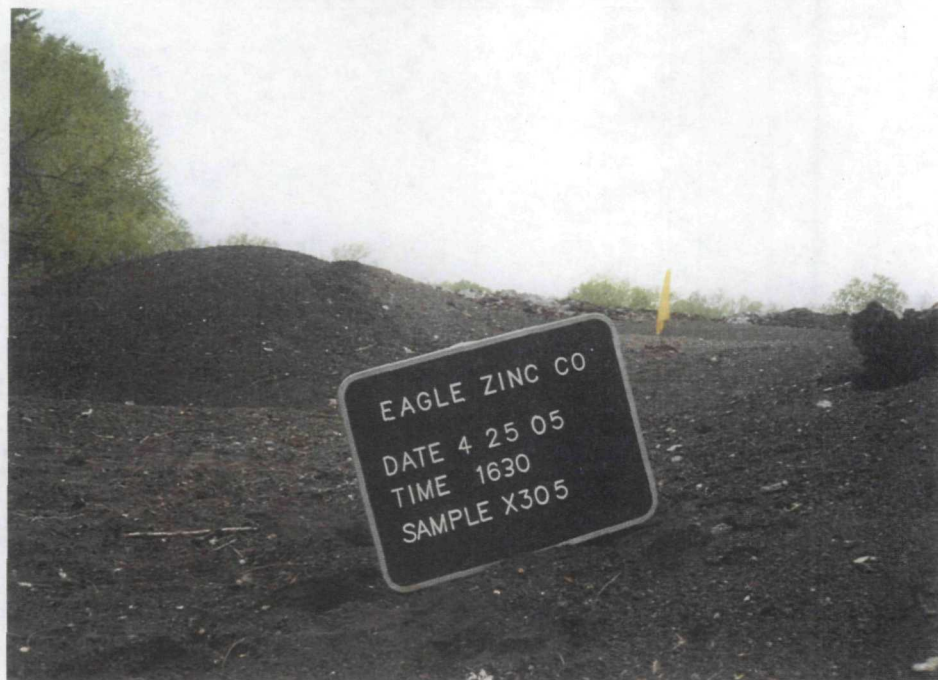
PHOTOGRAPH TAKEN BY: R. Casper
COMMENTS: Picture taken toward: West.
Photo Number 9.
Sample X305 was collected at the southwest area of the site from a slag pile.

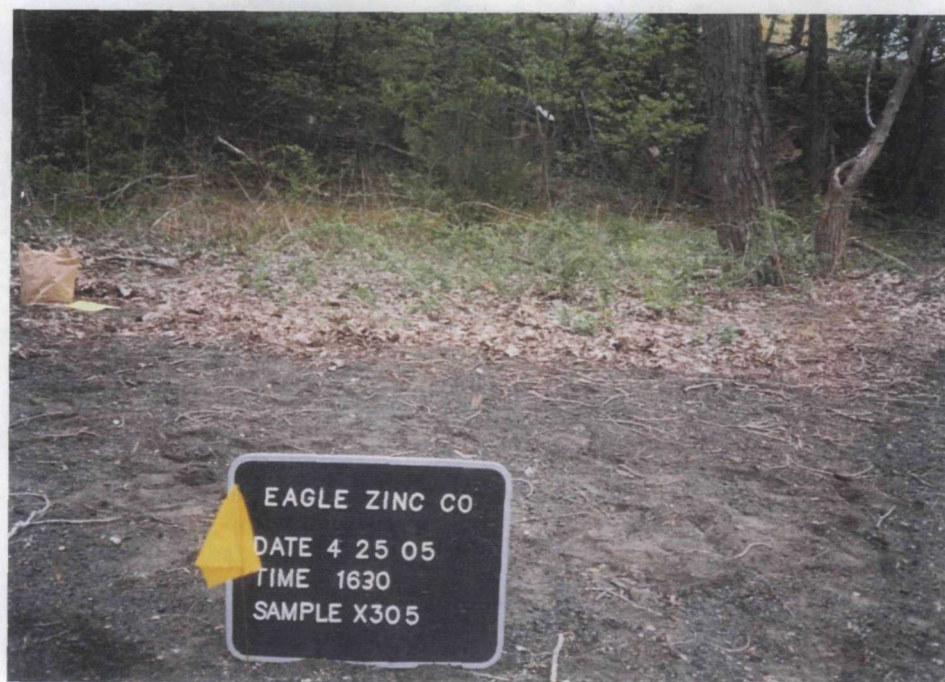
DATE: 4/25/05
TIME: 16:30
PHOTOGRAPH TAKEN BY: R. CASPER
COMMENTS: Picture taken toward: South.
Photo Number 10.
Sample X305. The sample consisted of a fine black- brown slag collect- ed at a depth of 0 to 2 inches.

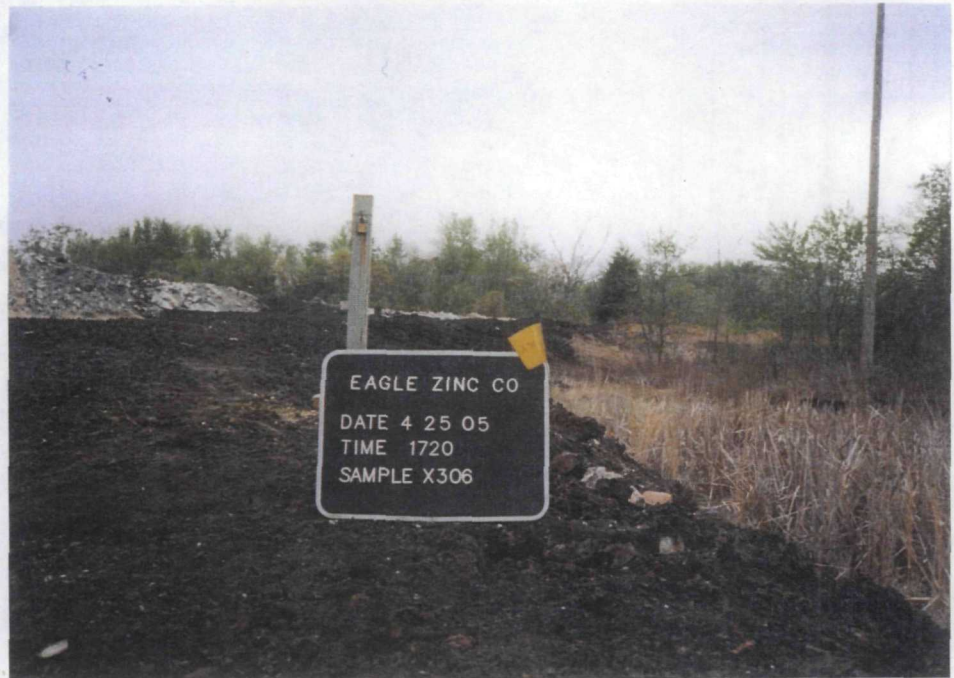
DATE: 4/25/05	SITE ILD#: 980606941	COUNTY: Montgomery
TIME: 17:20	SITE NAME: Eagle Zinc Co.	
PHOTOGRAPH TAKEN BY: R. Casper		
COMMENTS: Picture taken toward: South.		
Photo Number 11.		
Sample X306 was collected at the southwest area of the site from a slag & cinder pile.

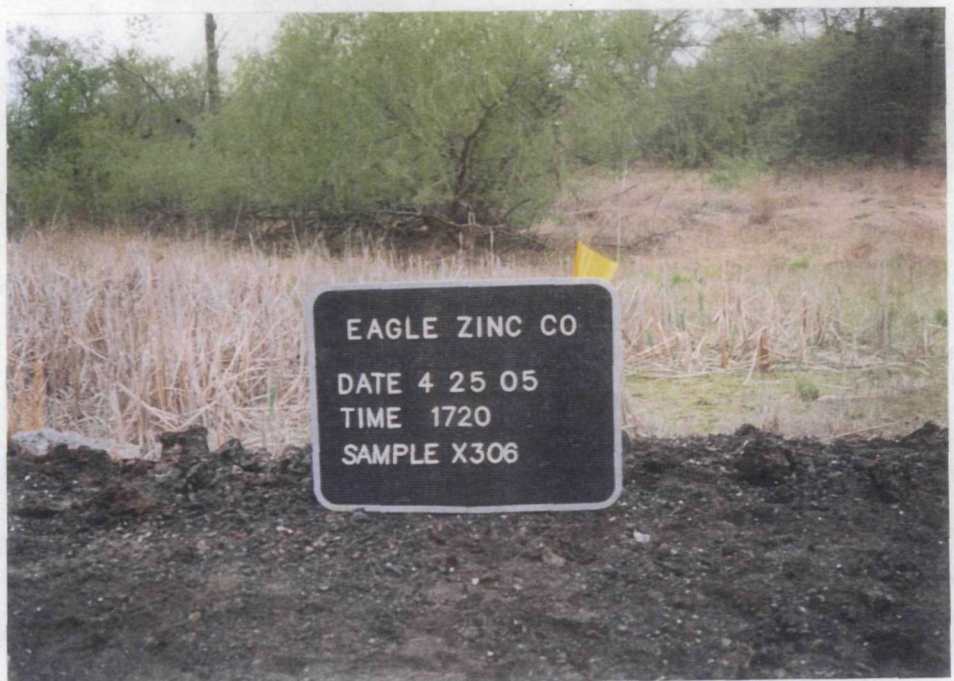
DATE: 4/25/05
TIME: 17:20
PHOTOGRAPH TAKEN BY: R. CASPER
COMMENTS: Picture taken toward: West.
Photo Number 12.
Sample X306. The sample consisted of a gray material collected at a depth of 0 to ½ inches.

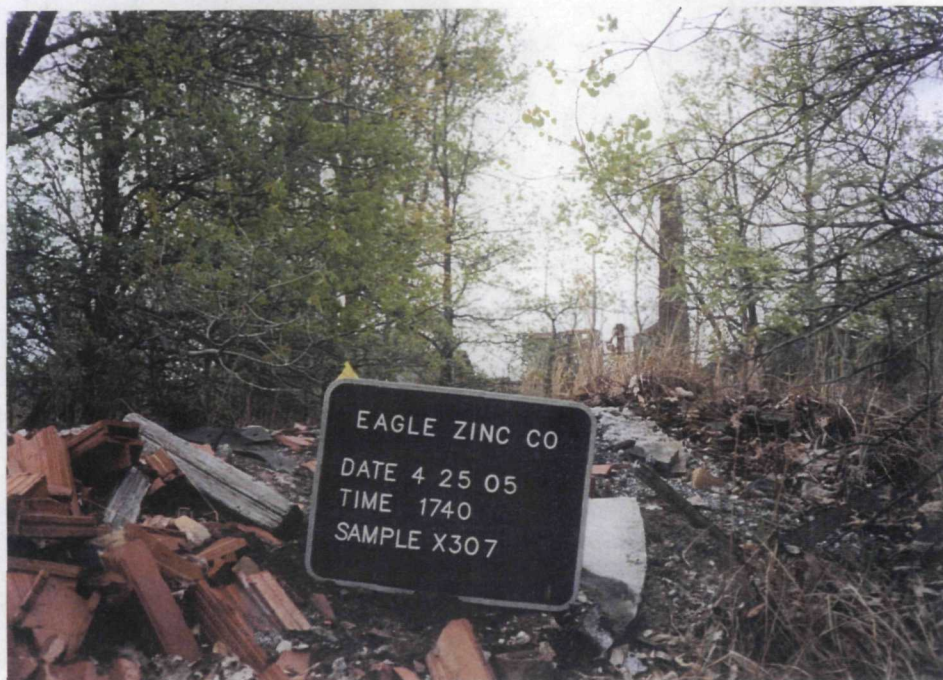
PHOTOGRAPH TAKEN BY: R. Casper
COMMENTS: Picture taken toward: East.
Photo Number 13.
Sample X307 was collected at the west central area of the site from a cinder/brick pile.

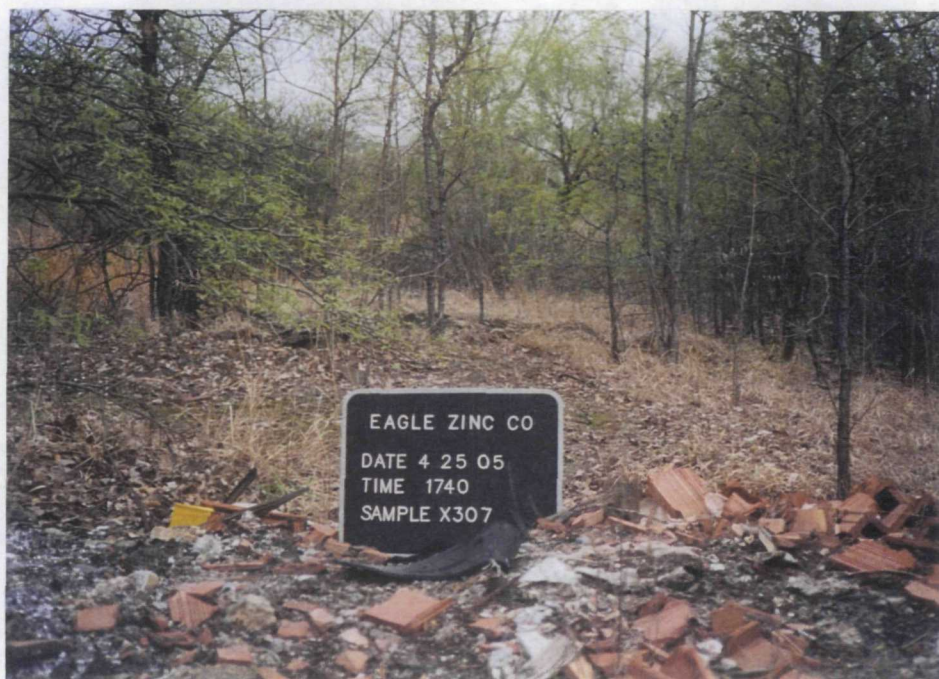
DATE: 4/25/05
TIME: 17:40
PHOTOGRAPH TAKEN BY: R. CASPER
COMMENTS: Picture taken toward: South.
Photo Number 14.
Sample X307. The sample consisted of a fine brown/ gray material col- lected at a depth 0 to ½ inches.

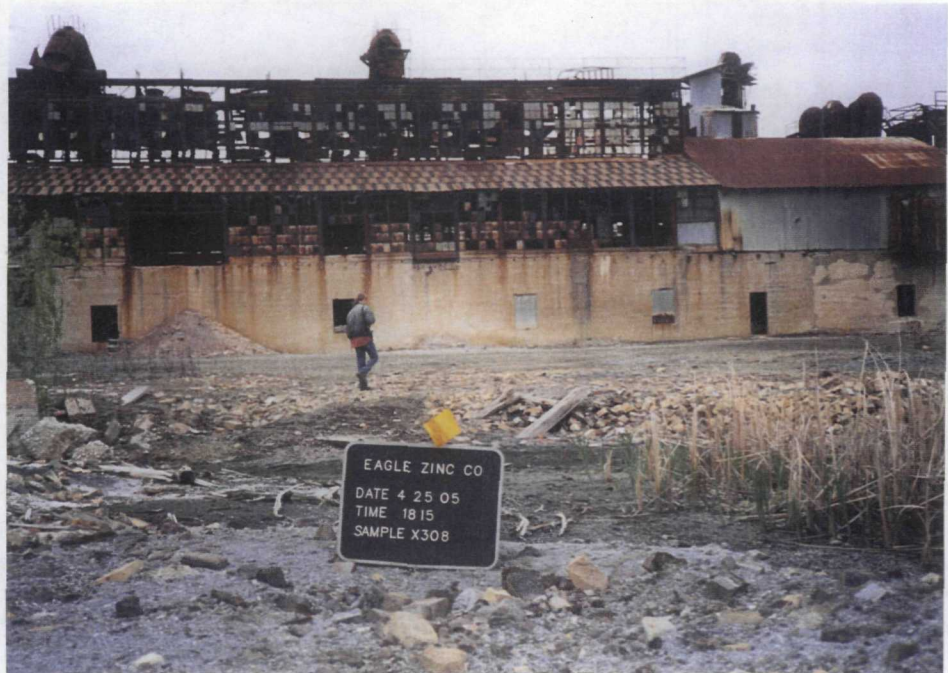
DATE: 4/25/05	SITE ILD#: 980606941	COUNTY: Montgomery
TIME: 18:15	SITE NAME: Eagle Zinc Co.	
PHOTOGRAPH TAKEN BY: R. Casper		
COMMENTS: Picture taken toward: east.		
Photo Number 15.		
Sample X308 was collected at the central area of the site from a slag pile.

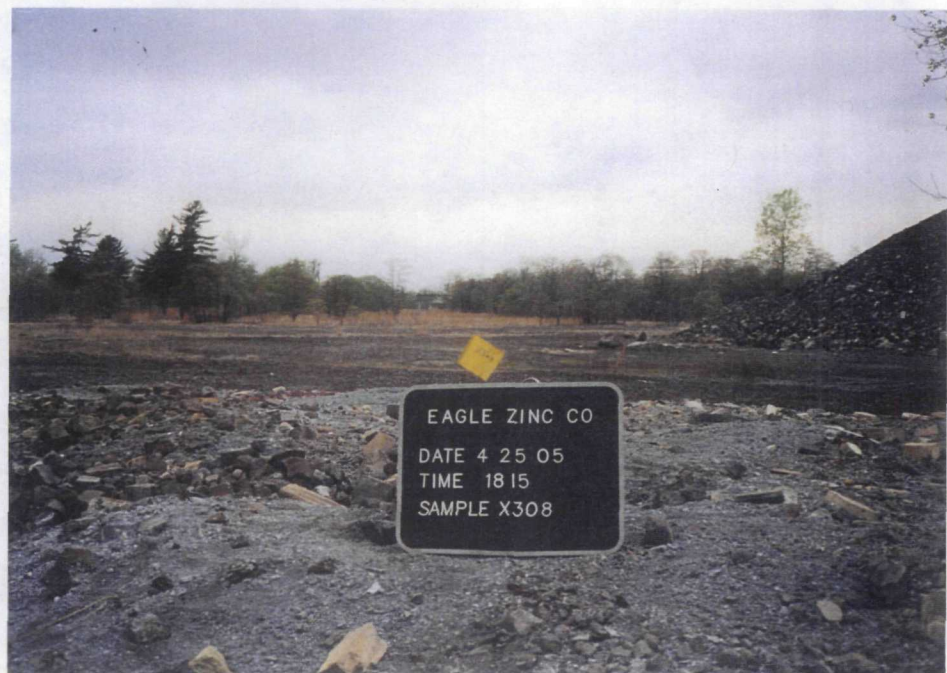
DATE: 4/25/05
TIME: 18:15
PHOTOGRAPH TAKEN BY: R. CASPER
COMMENTS: Picture taken toward: West.
Photo Number 16.
Sample X308. The sample consisted of light gray slag fines collected at a depth of 0 to ½ inches.

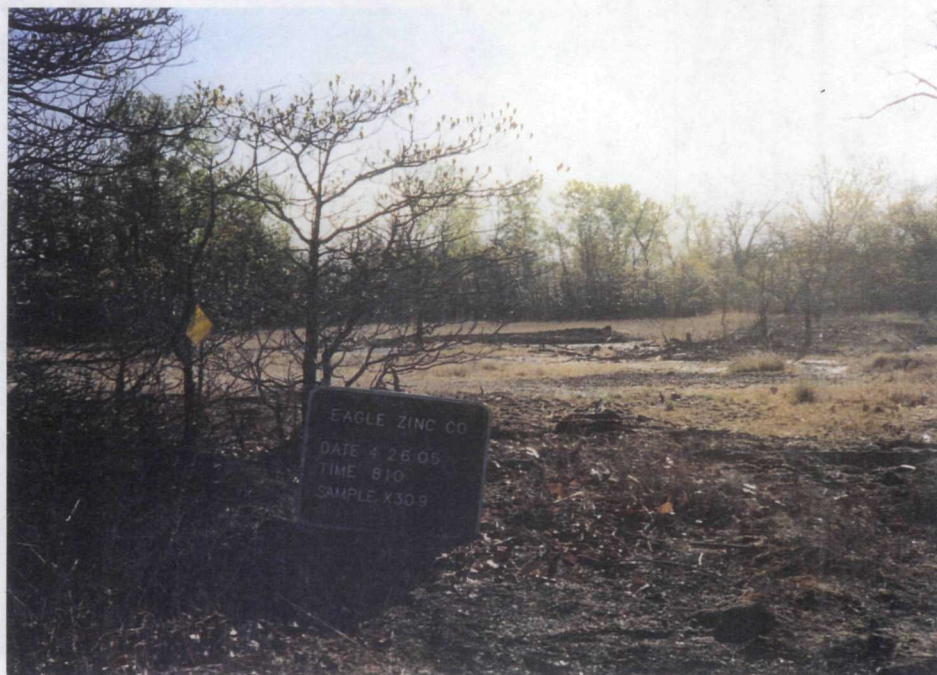
PHOTOGRAPH TAKEN BY: R. Casper
COMMENTS: Picture taken toward: East.
Photo Number 17.
Sample X309 was collected at the northwest area of the site from a slag pile.

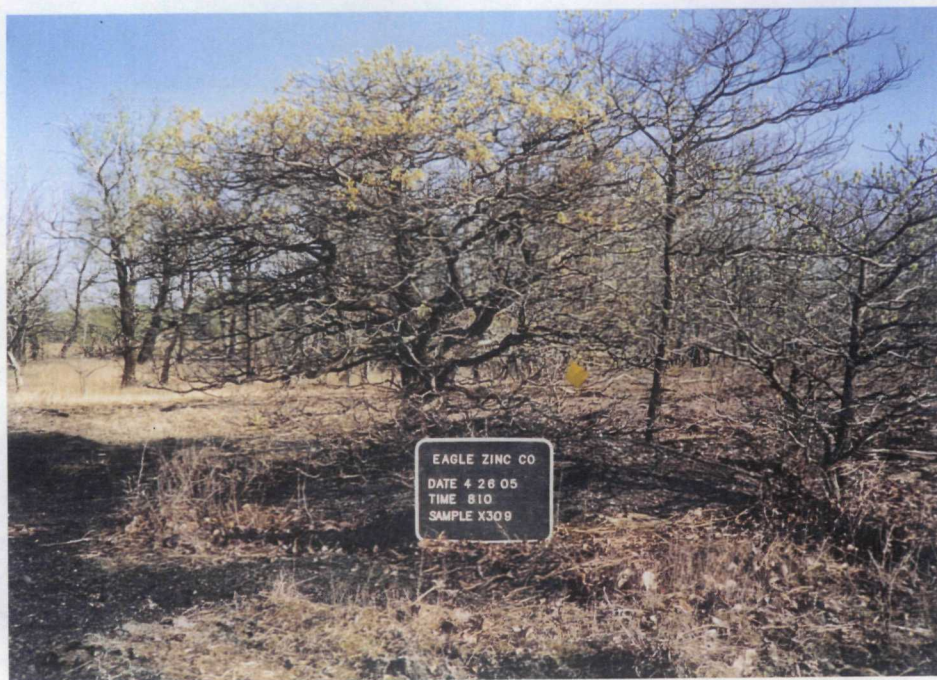
DATE: 4/26/05
TIME: 8:10
PHOTOGRAPH TAKEN BY: R. CASPER
COMMENTS: Picture taken toward: North.
Photo Number 18.
Sample X309. The sample consisted of a fine medium gray material with metal shavings, depth 0 to 1/2 inches

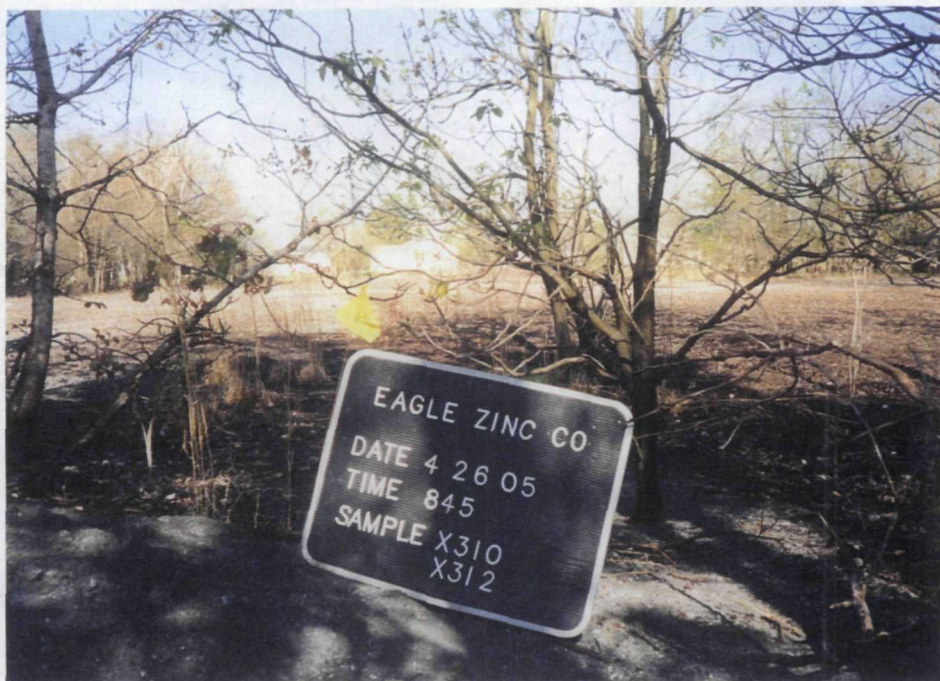
PHOTOGRAPH TAKEN BY: R. Casper
COMMENTS: Picture taken toward: West.
Photo Number 21.
duplicate samples
X310/X312 collected
at the northwest
area of the site.

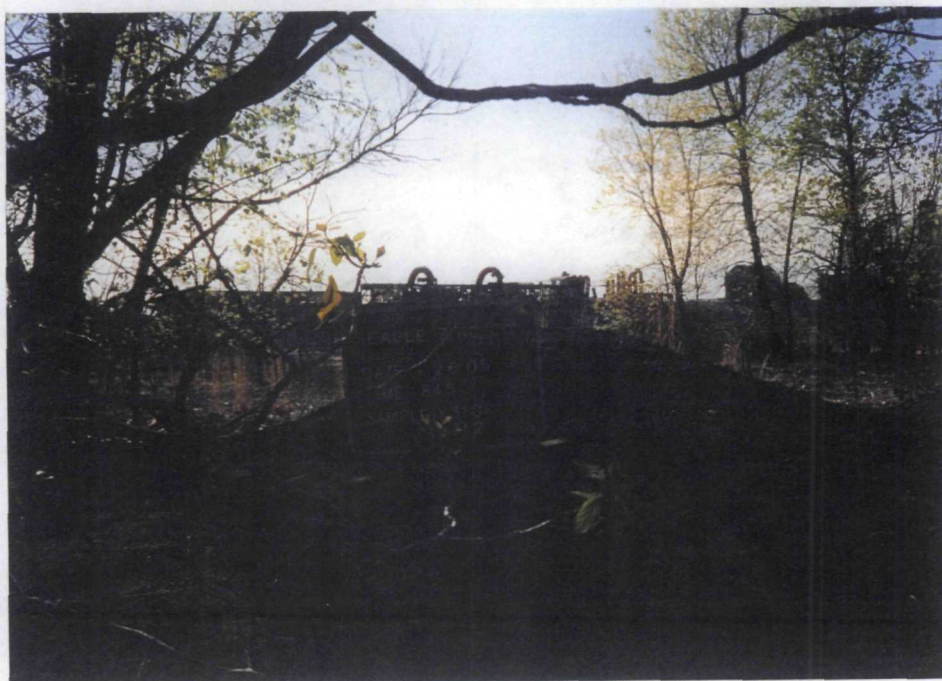
DATE: 4/26/05
TIME: 8:45
PHOTOGRAPH TAKEN BY: R. CASPER
COMMENTS: Picture taken toward: East.
Photo Number 22.
Samples X310/X312.
Sample consisted
of a fine medium
gray slag material.

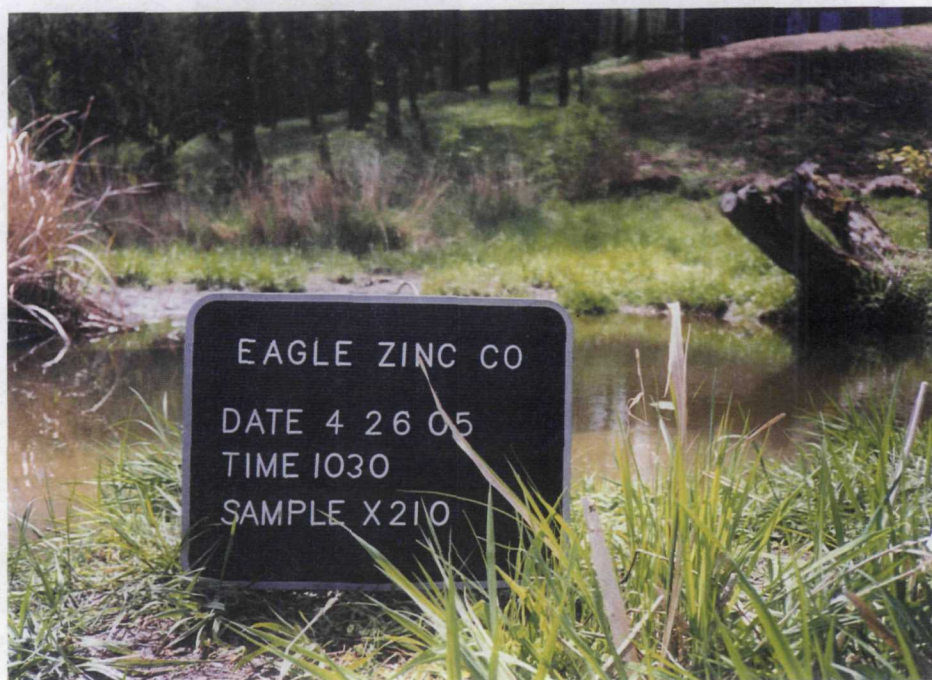
PHOTOGRAPH TAKEN BY: R. Casper
COMMENTS: Picture taken toward: East.
Photo Number 25.
Sample X210 was collected from a brownish-gray silty clay sediment at a depth of 3" to 5".

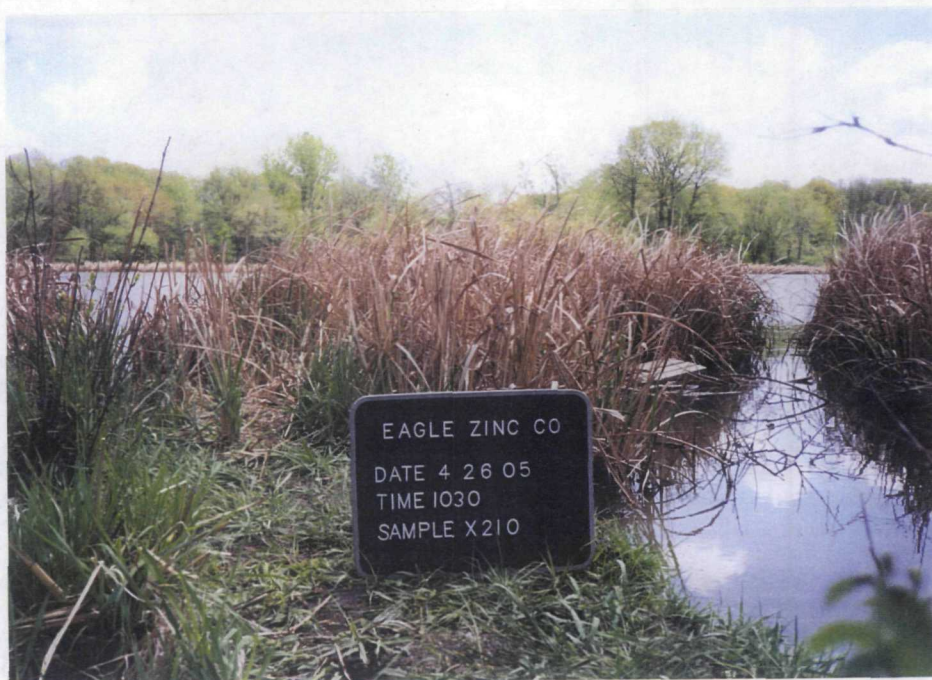
DATE: 4/26/05
TIME: 10:30
PHOTOGRAPH TAKEN BY: R. CASPER
COMMENTS: Picture taken toward: North.
Photo Number 26.
Sample X210 was consisted near the point where drain- age from the site enters Lake Hillsboro.

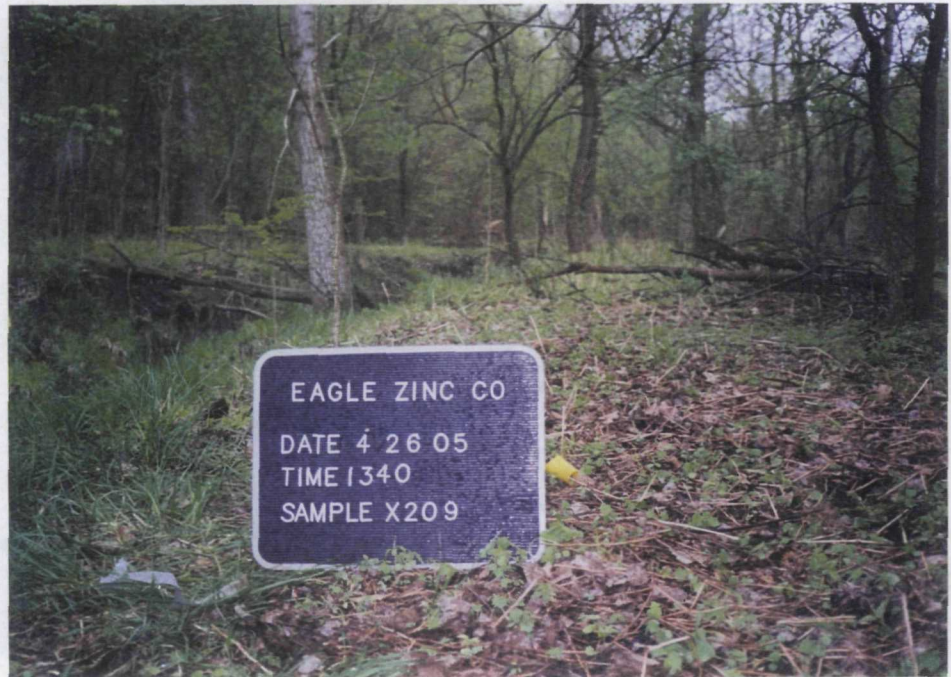
PHOTOGRAPH TAKEN BY: R. Casper
COMMENTS: Picture taken toward: South.
Photo Number 29.
Sample X209 was collected south of Smith road, in the offsite drainage pathway.

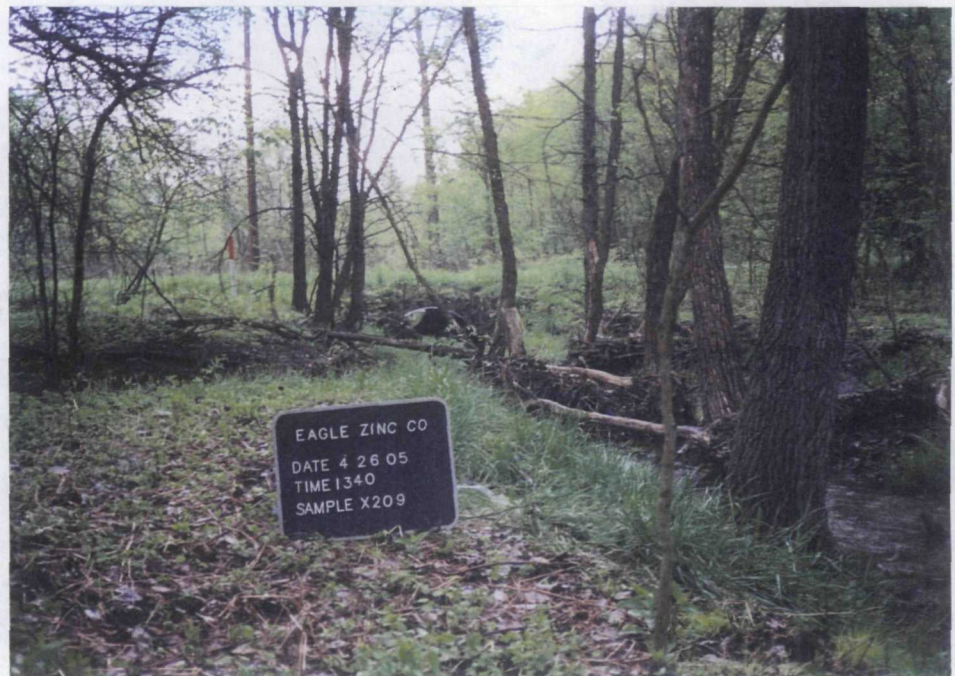
DATE: 4/26/05
TIME: 13:40
PHOTOGRAPH TAKEN BY: R. CASPER
COMMENTS: Picture taken toward: North.
Photo Number 30.
Sample X209. The sample consisted of a brown sandy clay with some silt and organic material.

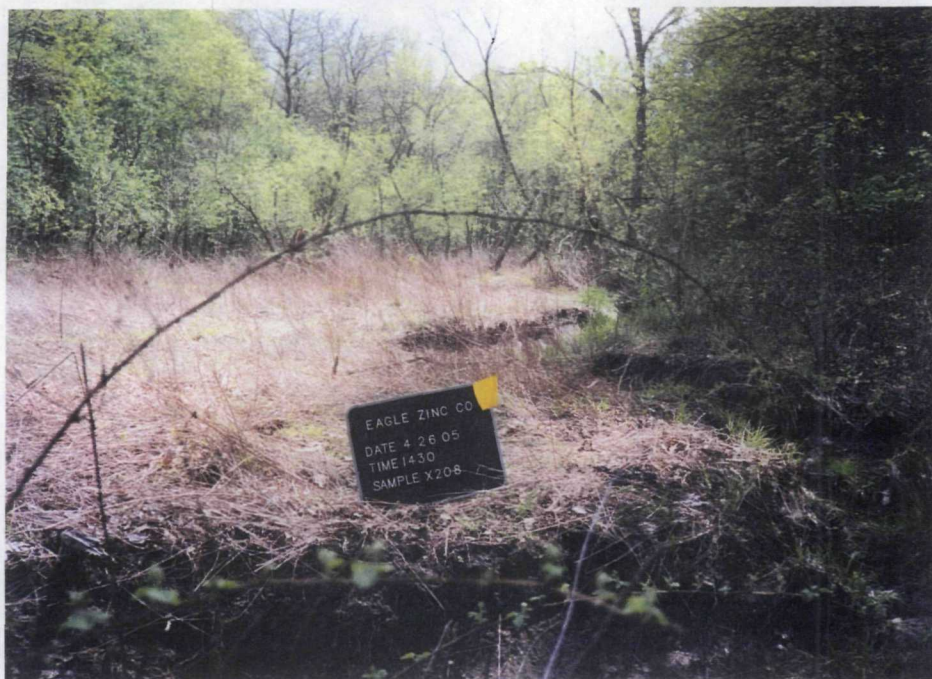
DATE: 4/26/05	SITE ILD#: 980606941	COUNTY: Montgomery
TIME: 14:30	SITE NAME: Eagle Zinc Co.	
PHOTOGRAPH TAKEN BY: R. Casper		
COMMENTS: Picture taken toward: South.		
Photo Number 31.		
Sample X208 was collected in the offsite drainage pathway south of Smith Road.

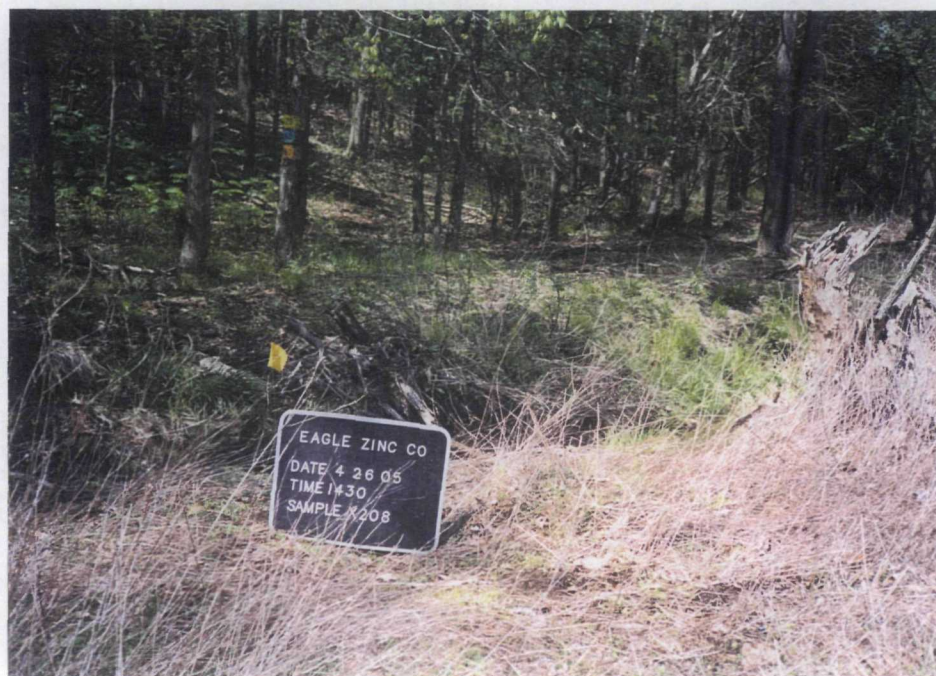
DATE: 4/26/05
TIME: 14:30
PHOTOGRAPH TAKEN BY: R. CASPER
COMMENTS: Picture taken toward: North.
Photo Number 32.
Sample X208. The sample consisted of a brown silt. Collected at a depth of 0 to 2 inches.

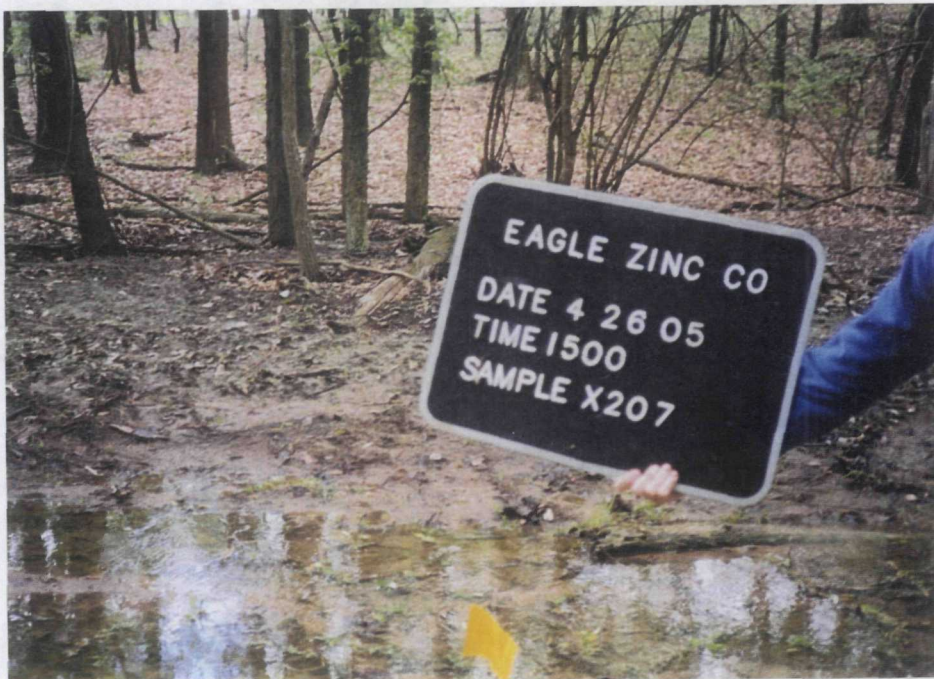
DATE: 4/26/05	SITE ILD#: 980606941	COUNTY: Montgomery
TIME: 15:00	SITE NAME: Eagle Zinc Co.	
PHOTOGRAPH TAKEN BY: R. Casper		
COMMENTS: Picture taken toward: West.		
Photo Number 33.		
Sample X207 was collected from the drainage pathway southeast of the site.

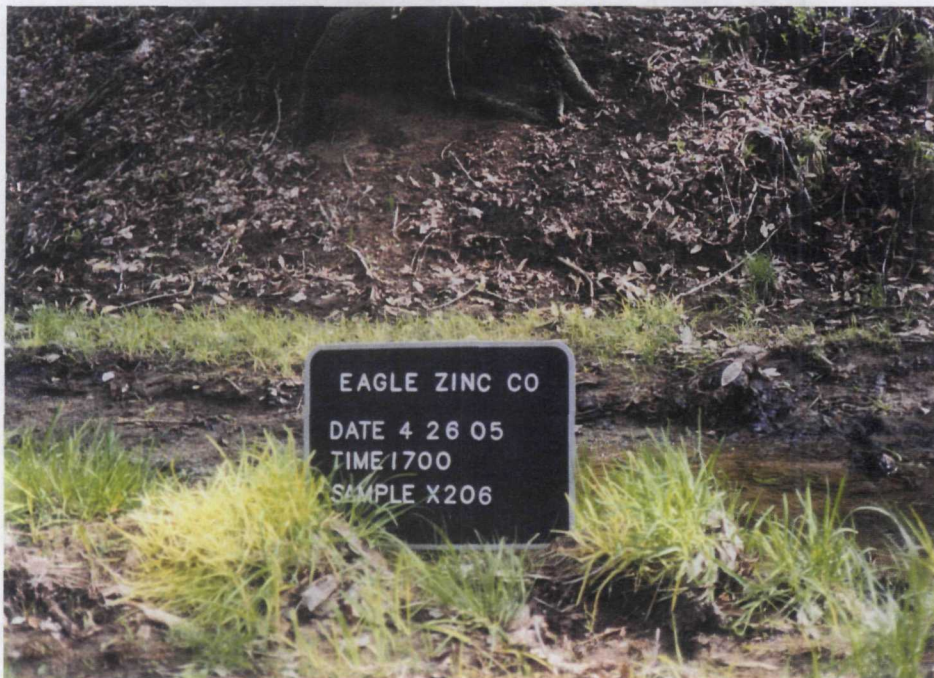
DATE: 4/26/05	SITE ILD#: 980606941	COUNTY: Montgomery
TIME: 17:00	SITE NAME: Eagle Zinc Co.	
PHOTOGRAPH TAKEN BY: R. Casper		
COMMENTS: Picture taken toward: South.		
Photo Number 35.		
Sample X206 was collected offsite east of Industrial Park Road.

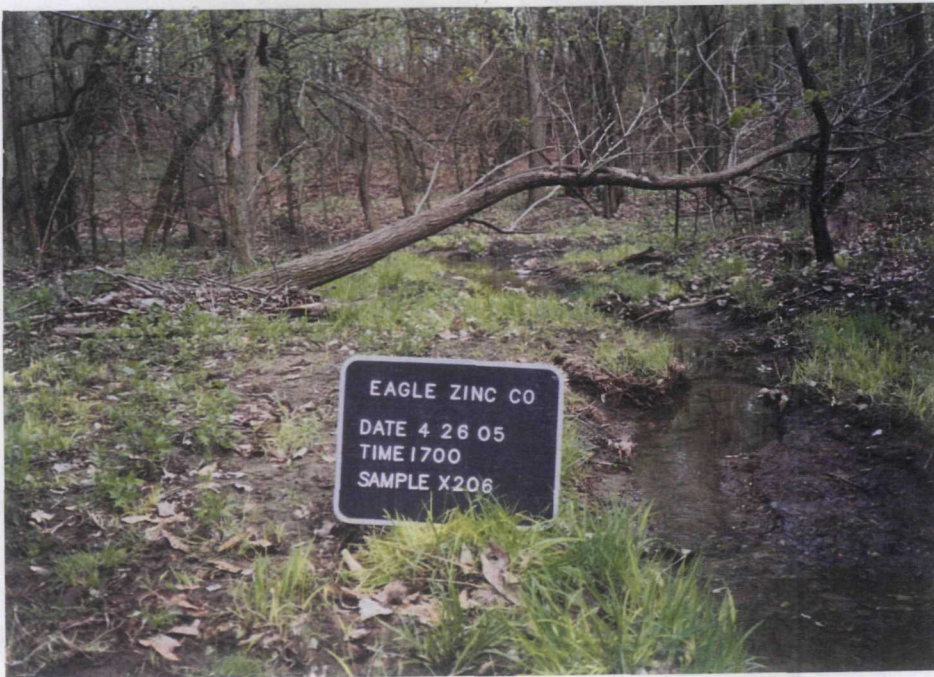
DATE: 4/26/05
TIME: 17:00
PHOTOGRAPH TAKEN BY: R. CASPER
COMMENTS: Picture taken toward: East.
Photo Number 36.
Sample X206. The sample consisted of a brown silty clay, collected at a depth of 3 to 5 inches.

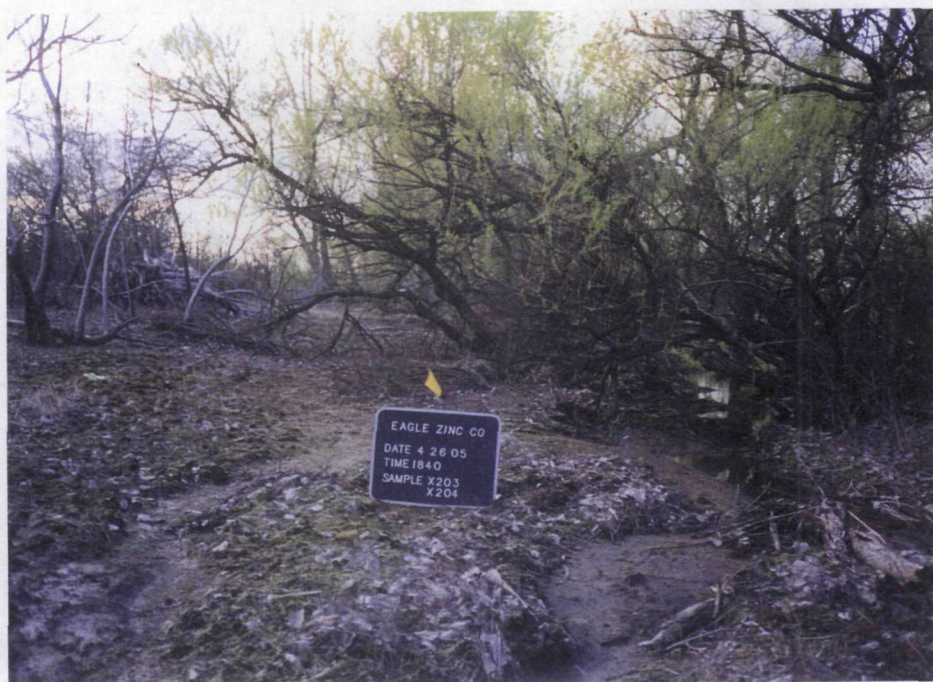
PHOTOGRAPH TAKEN BY: R. Casper
COMMENTS: Picture taken toward: West.
Photo Number 39.
Duplicate samples X203/X204 collected onsite west of Industrial Park Road.

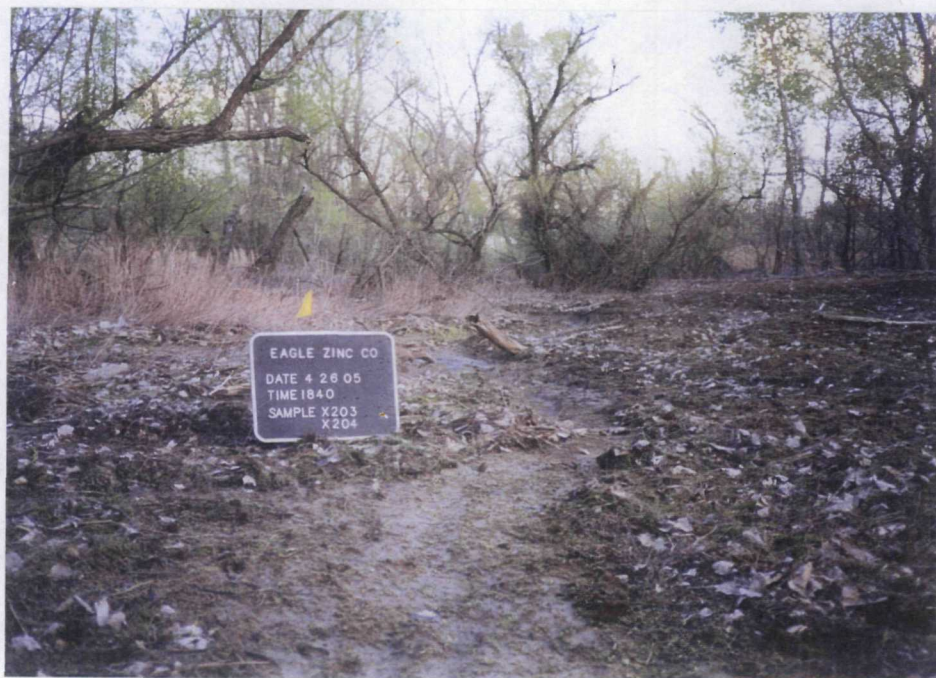
DATE: 4/27/05
TIME: 18:40
PHOTOGRAPH TAKEN BY: R. CASPER
COMMENTS: Picture taken toward: East.
Photo Number 40.
Samples X203/X204.
The samples consisted of a brown silty clay. Collected 0 to 2 inches deep.

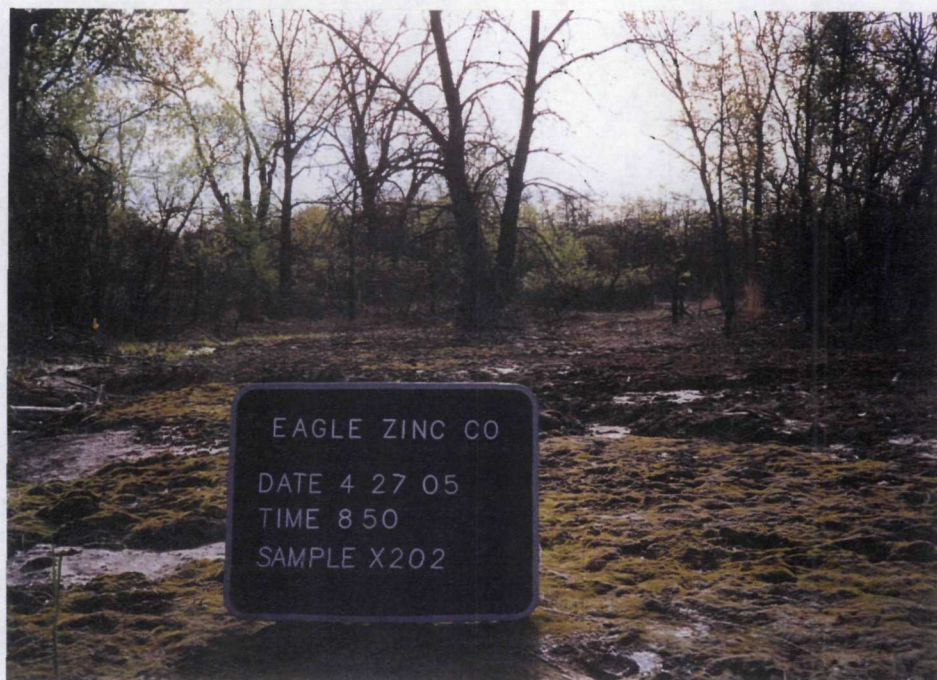
PHOTOGRAPH TAKEN BY: R. Casper
COMMENTS: Picture taken toward: East.
Photo Number 41.
Sample X202 was collected in the onsite drainage pathway.

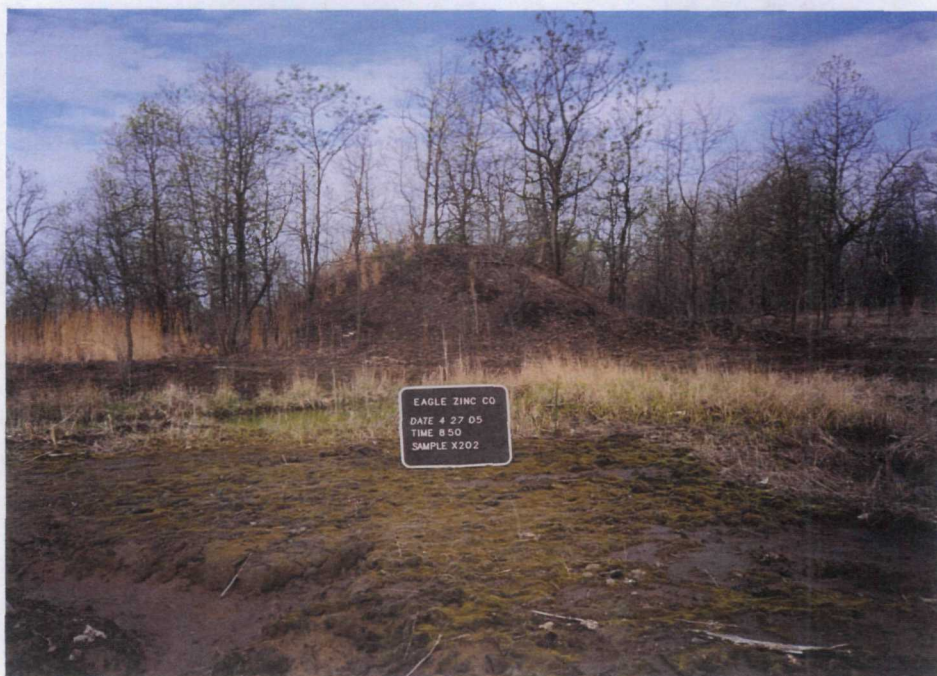
DATE: 4/27/05
TIME: 8:50
PHOTOGRAPH TAKEN BY: R. CASPER
COMMENTS: Picture taken toward: West.
Photo Number 42.
Sample X202. The sample consisted of a gray silty clay collected at a depth of 0 to 2 inches.

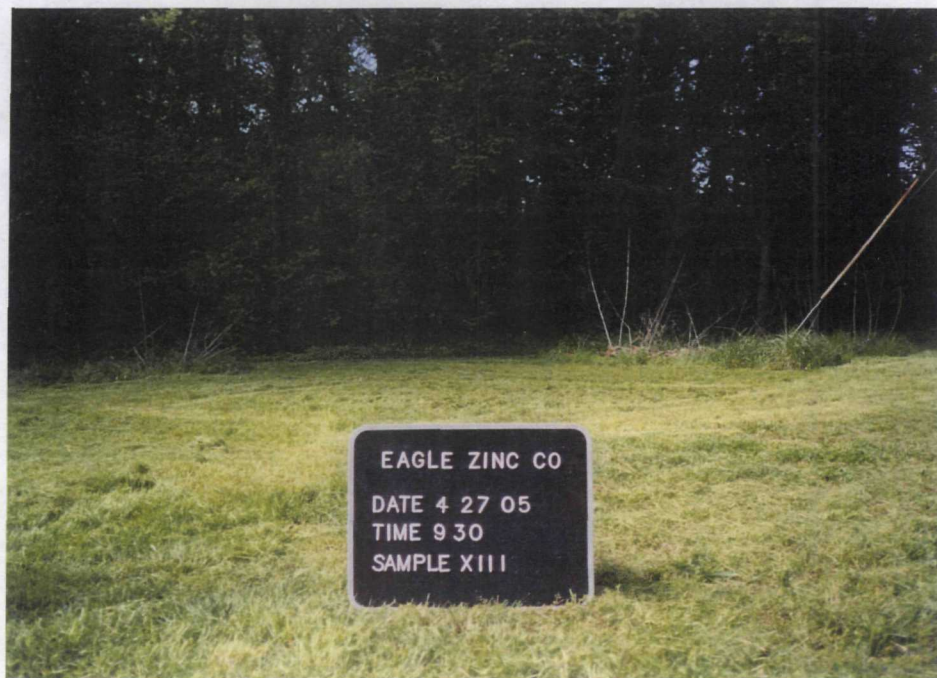
DATE: 4/27/05	SITE IL# #: 980606941	COUNTY: Montgomery
TIME: 9:30	SITE NAME: Eagle Zinc Co.	
PHOTOGRAPH TAKEN BY: R. Casper		
COMMENTS: Picture taken toward: South.		
Photo Number 43.		
Sample X111 was collected from a residential yard west of the site.

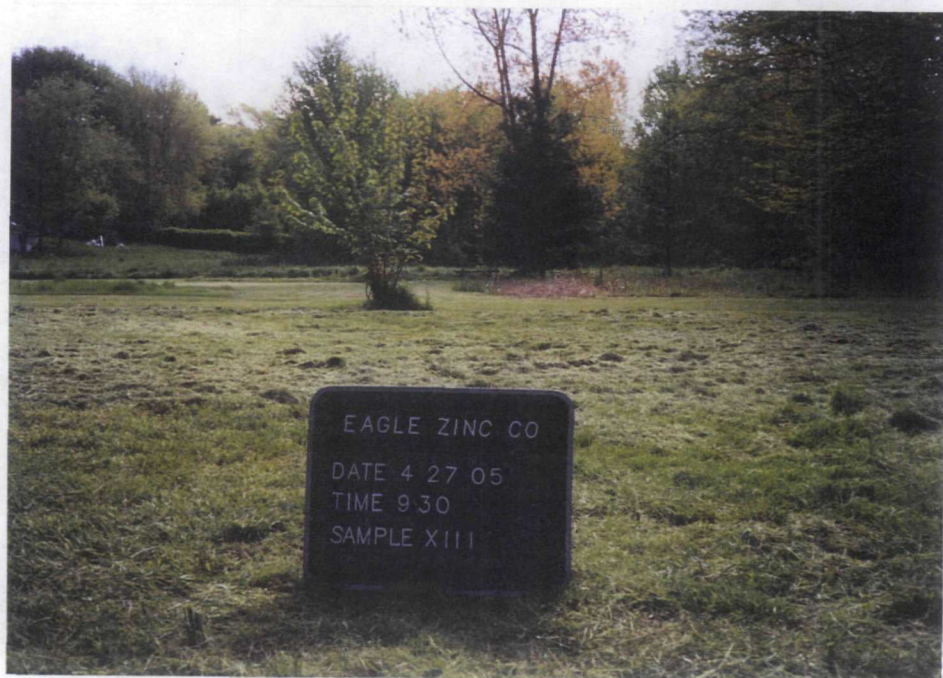
DATE: 4/27/05
TIME: 9:30
PHOTOGRAPH TAKEN BY: R. CASPER
COMMENTS: Picture taken toward: East.
Photo Number 44.
Sample X111. The sample consisted of a black silty loam collected at a depth of 0 to 1 inch.

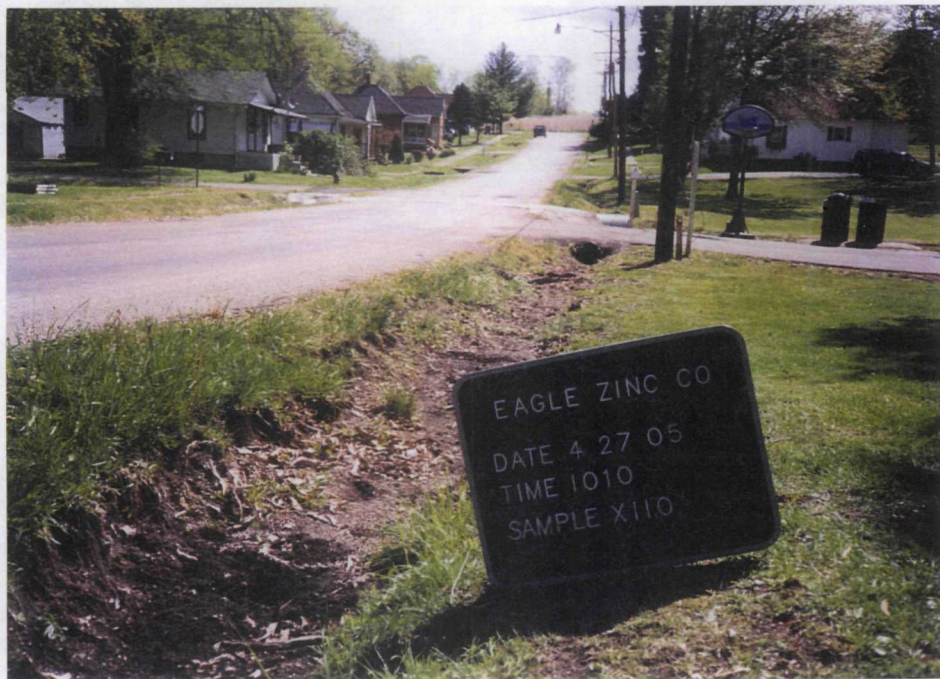
DATE: 4/27/05	SITE ILD#: 980606941	COUNTY: Montgomery
TIME: 10:10	SITE NAME: Eagle Zinc Co.	
PHOTOGRAPH TAKEN BY: R. Casper		
COMMENTS: Picture taken toward: East.		
Photo Number 47.		
Sample X110 was collected from a residential area west of the site.
